HIGH VELOCITY IMPACT

**Hensselaer Polytechnic Institute
in partial fulfillment of the re-
quirements for the
Degree of Master of Civil Engineering**

**Summer Term
1948**

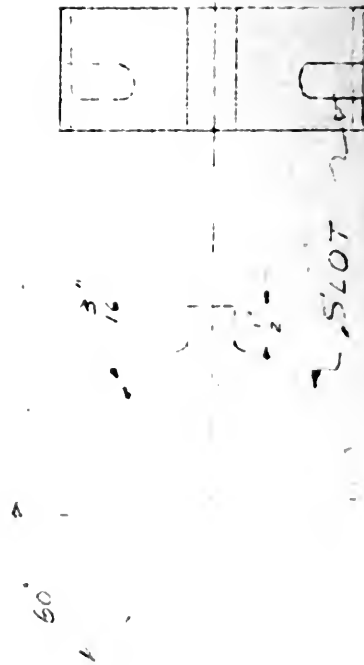
FIG. 5

HAMMER & PIN - FULL SCALE

RING - HALF SCALE

DETAILS OF LOADING MACHINE

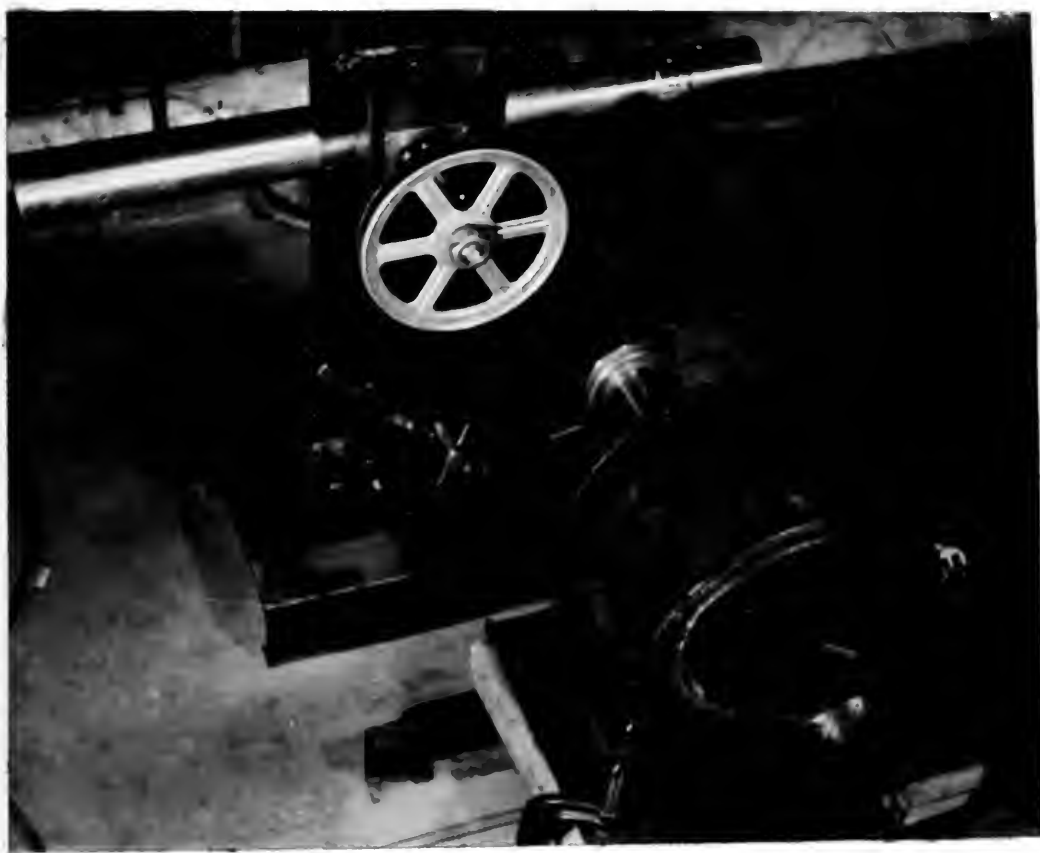
PHOTO A
General view of Loading Machine

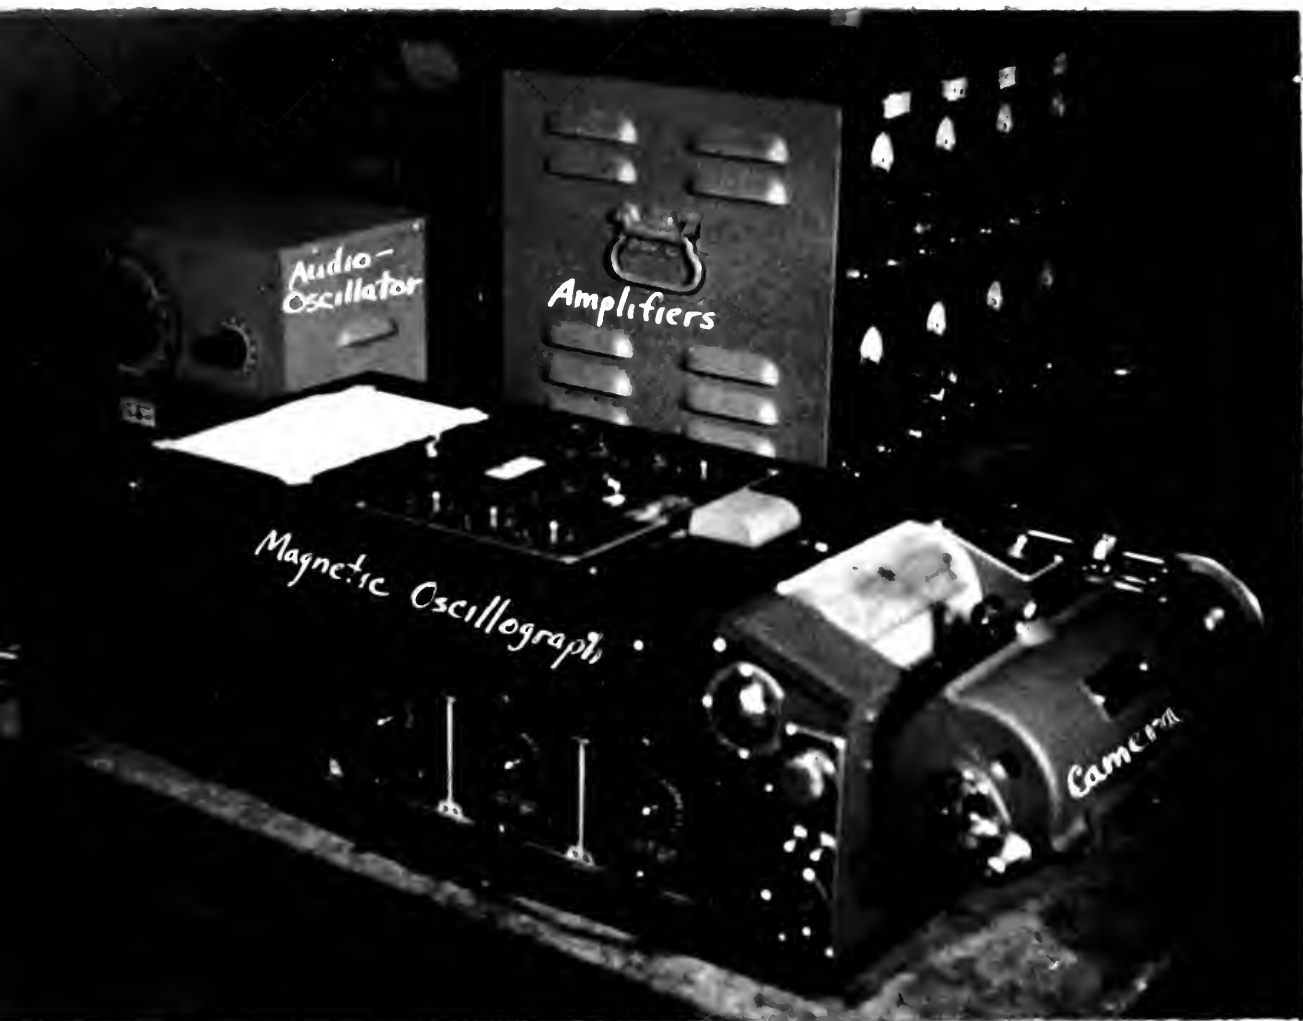
View of Instruments

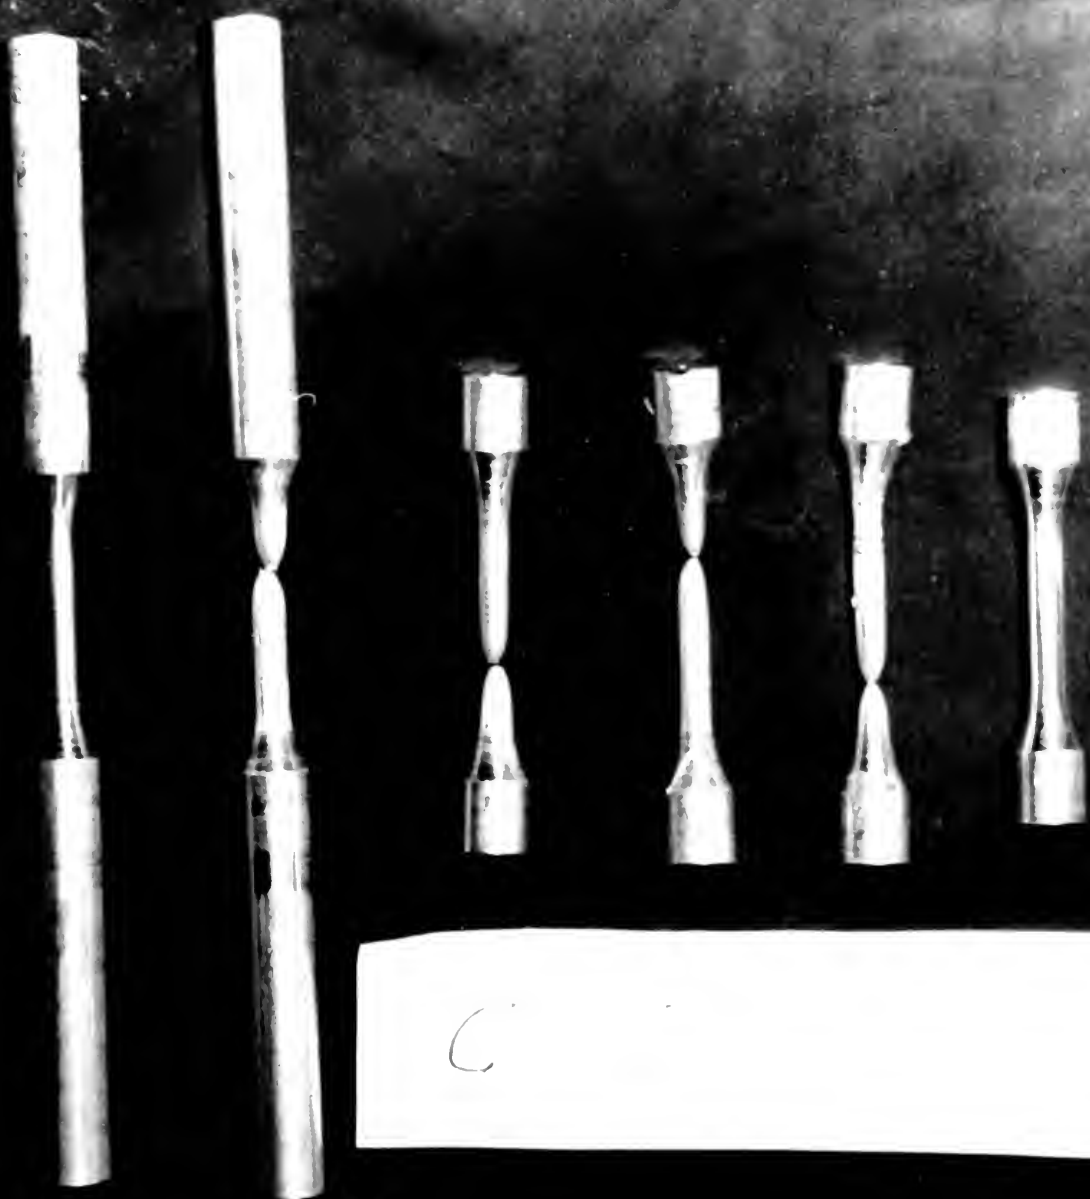
Specimen - 100 - 1
 - Static - before testing
 " - " - after
 " - 1 - et - fractured at 52 f.s.
 " - " - " - " 17 "
 " - " - " - " 180 "
 " - " - " - static testing

Specimen (see photo. J)	Velocity of loading (fps)	Nature of fracture
B	0 (static)	ragged concave
C	57	perfect concave
D	132	perfect concave
E	189	perfect concave
